Teaching Case Studies in Reservoir Siltation and Catchment Erosion*

H. CHANSON

PATRICK JAMES

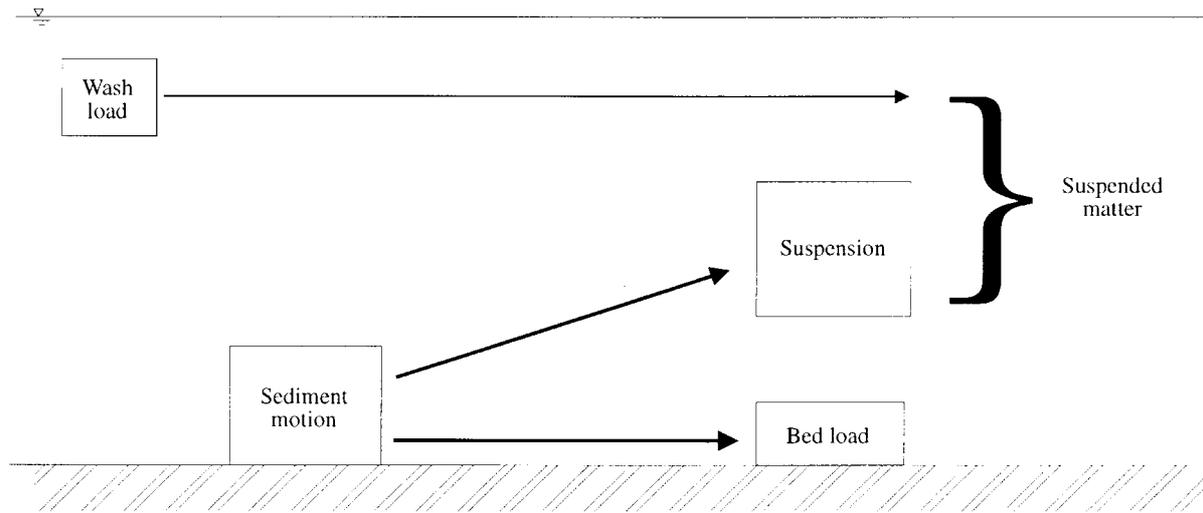
Fig. 1. Sediment transport classification.

- Sediment transport is the general term used for the transport of material (e.g. silt, sand, gravel, boulder) in rivers and streams.
- The transported material is called the 'sediment load'.
- Distinction is made between the 'bed load' and the 'suspended load', the bed load characterises grains rolling along the bed while suspended load refers to grains maintained in suspension by turbulence.
- The total sediment discharge in a stream is the total volume of sediment particles in motion per unit time. It includes the sediment transport by bed load motion and by suspension as well as the 'wash load' (Fig. 1).

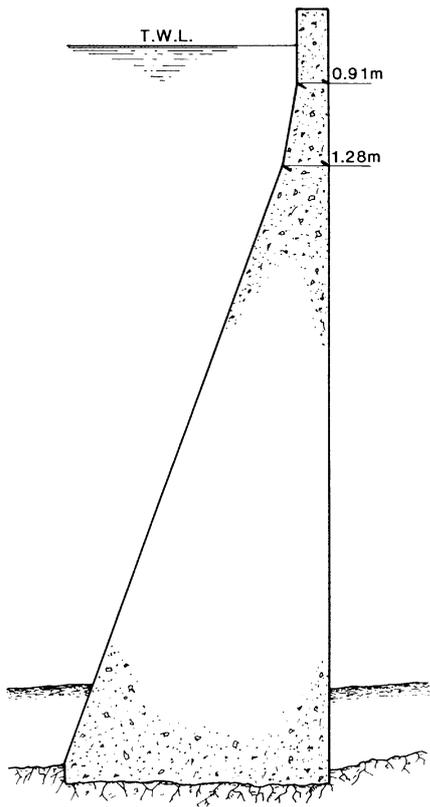
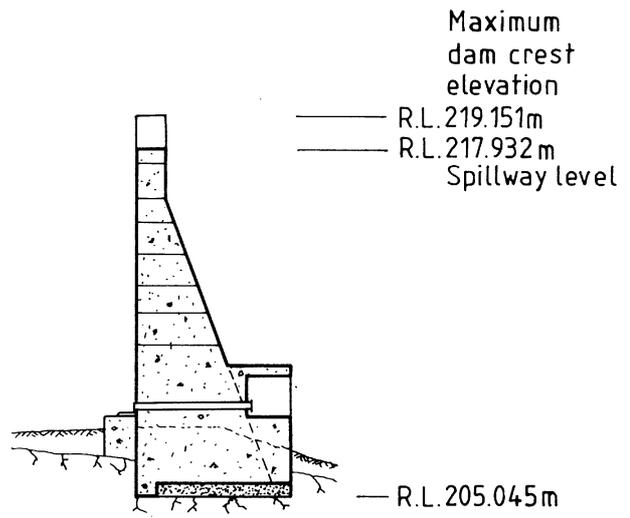
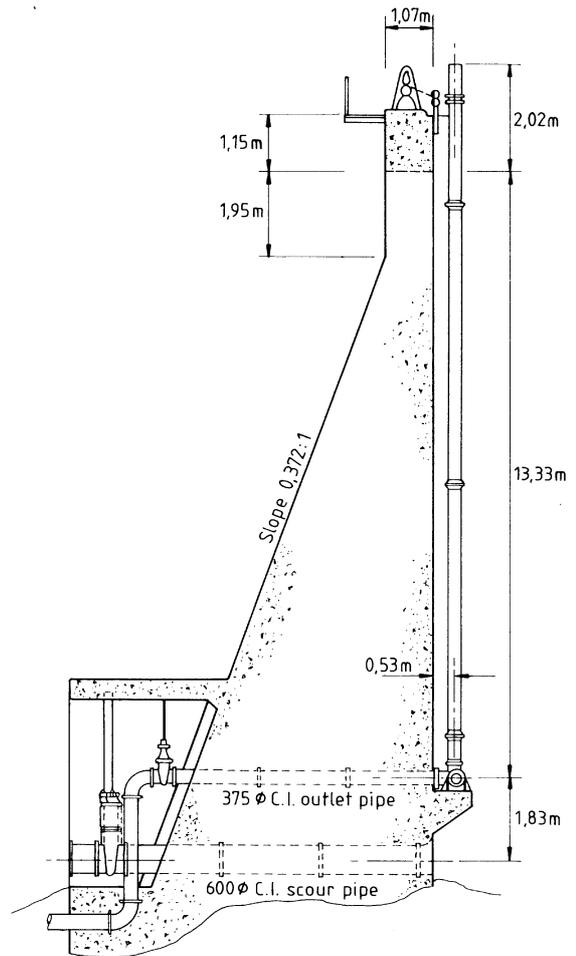
Fig. 2. Cross-sections of thin arch walls. (A) Moore Creek. (B) Korrumbyn Creek. (C) Quipolly.

MOORE CREEK DAM

KORRUMBYN CREEK DAM

QUIPOLLY DAM

The Moore Creek Dam was originally called the Tamworth Dam and completed in 1898. It is a 18.6-m high dam which incorporated significant advances in structural design: i.e. thin single-arch (7.7-m thick at base for 0.87-m thick at dam crest), made of Portland cement concrete. The arch wall has an unusual downstream vertical face and a inclined upstream face (Figs 2 and 3). The single arch extends with a left-bank gravity cross-section. The dam was equipped with a large overfall spillway ($Q \sim 100 \text{ m}^3/\text{s}$), a scour valve and a pipe outlet.

The Korrumbyn Creek Dam was completed in 1918 for water supply purposes. It is located less than 50 km from the Pacific coast. The wall is a 14.1 m high single arch (1.1 m thick at crest, 61 m radius in plan) with a left-bank extension of gravity cross-section (Fig. 5). The dam was equipped with two bottom outlets (pipe outlet and scour valve) and an overfall spillway ($Q \sim 125 \text{ m}^3/\text{s}$).

The Quipolly Dam (also known as old Quipolly Dam or Coypolly Creek Dam No. 1) was completed in 1932. The dam wall (Fig. 6) is a slender arch in comparison with Moore Creek

Dam and Korrumbyn Creek Weir, both designed with a (thicker) gravity section. It is a concrete single-arch (1.08 m thickness at crest). The dam was equipped with two bottom outlets and an overfall spillway ($Q \sim 240 \text{ m}^3/\text{s}$).

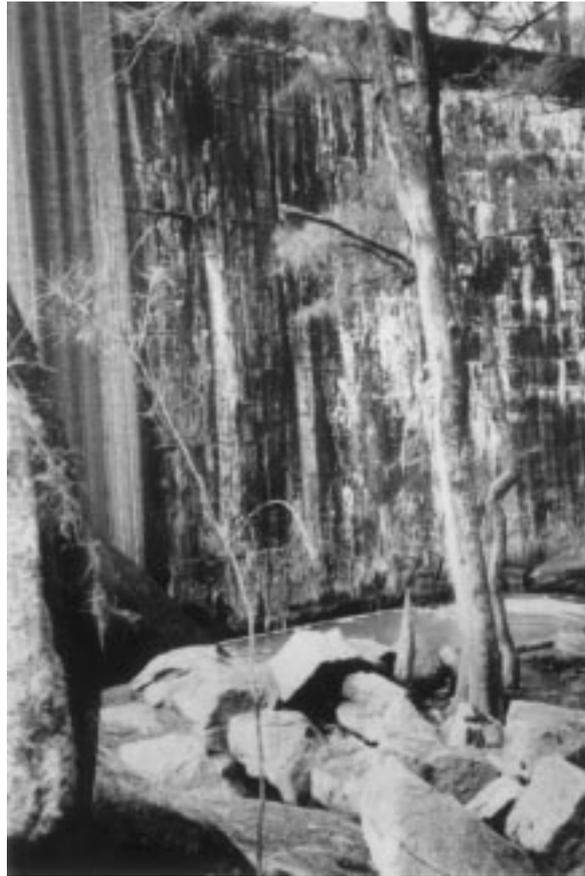
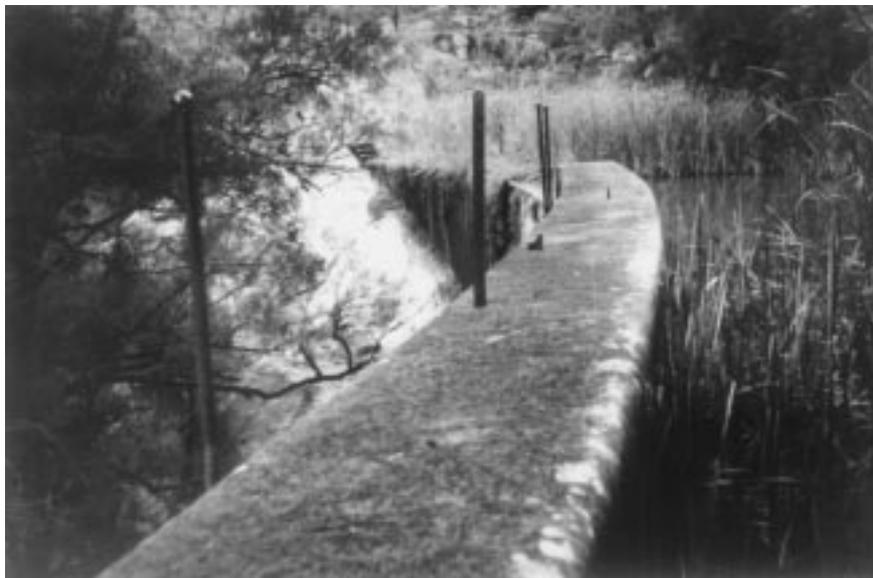
Fig. 3. Moore Creek Reservoir nowadays. Photographs taken on 14 June 1997 (by H. Chanson). (A) Downstream wall. The scour valve is visible just left of the tree. (B) Crest view, looking toward the right bank.

Rapid siltation of the reservoir was observed: 85000 m^3 of sediment had accumulated by 1911 (39% of original capacity). Records indicated that most siltation took place during two major floods with dam overtopping in February 1908 and January 1910. By 1924 the reservoir was fully-silted and disused.

The siltation of Moore Creek Reservoir was caused by rapid catchment erosion. At the end of the 19th century, the natural vegetation occupying the catchment was cleared for farming and stocking. It appears, further, that a significant increase in sheep livestock took place around 1890–1910. Both the clearing of the catchment and an increase of sheep cattle diminished the soil resistance against erosion during heavy rainfalls, hence contributing to the rapid sedimentation of the reservoir.

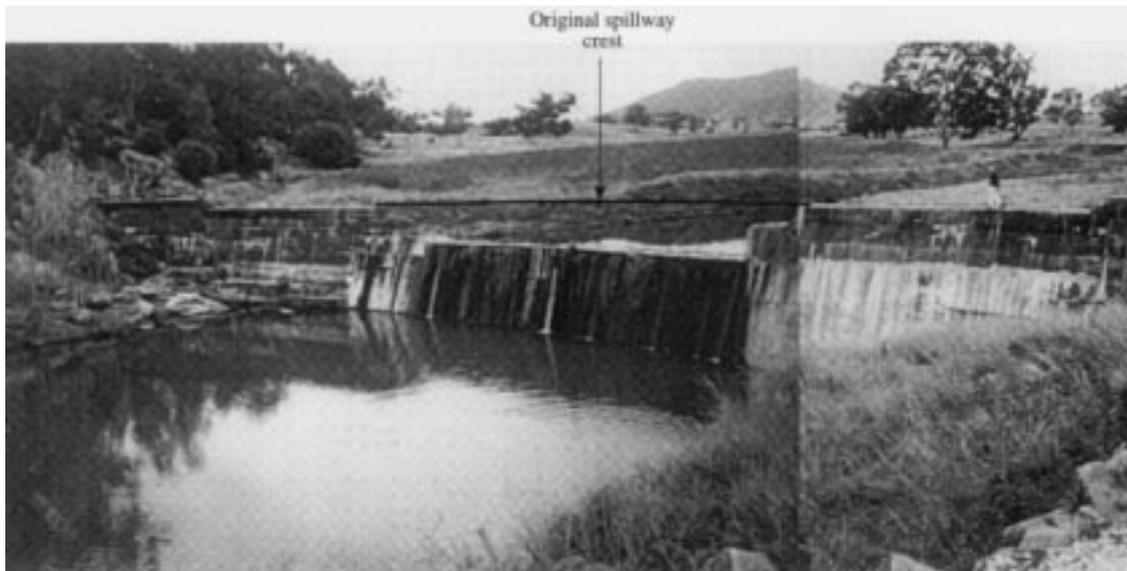
Fig. 4. The Gap Weir and its silted reservoir from a photograph taken on 13 June 1997 (by H. Chanson). The black line is the original spillway crest.

The Gap Weir was built without scour outlet and sediment could not be removed. Additionally the spillway capacity was very small compared to the other dams which have all smaller catchments (Tables 1 and 2).

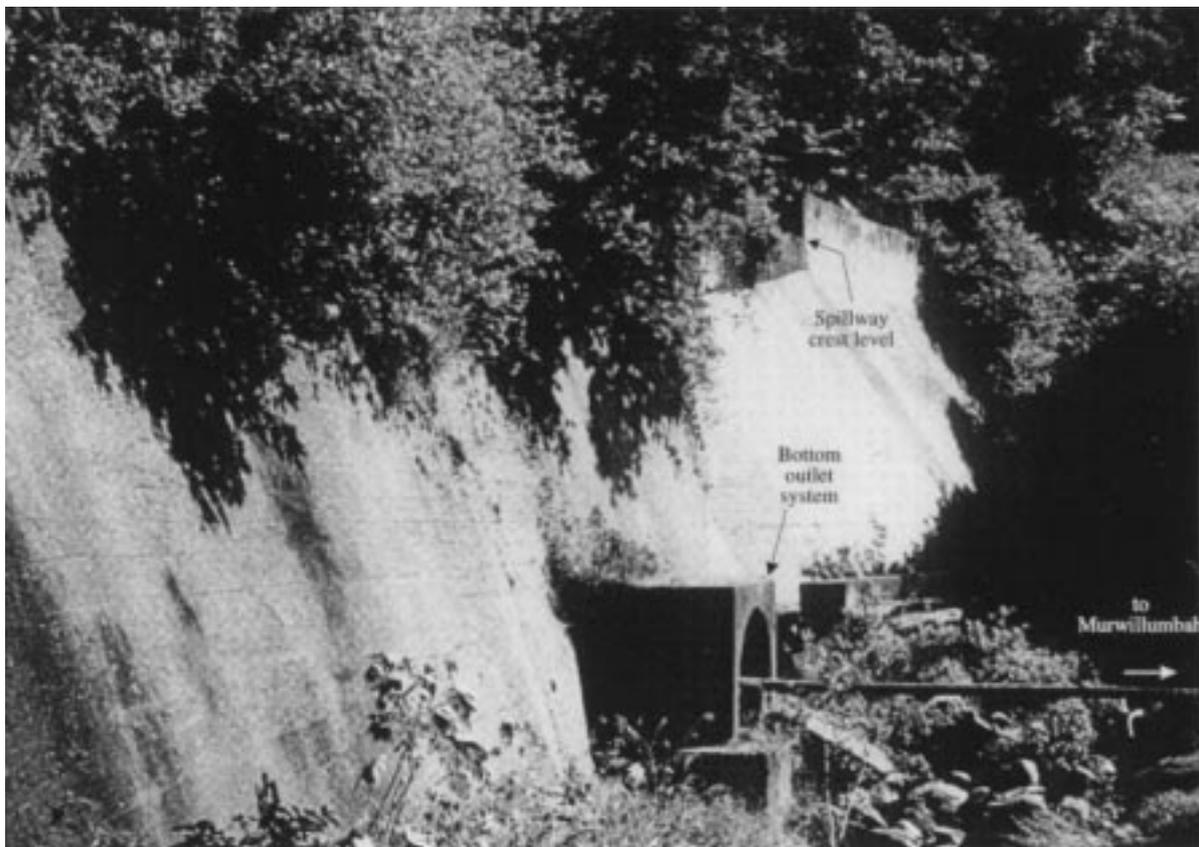
Fig. 5. Photograph of the Korrumbyn Creek Dam wall and the surrounding tropical rain forest. Photograph taken on 25 April 1997 (by H. Chanson).

The reservoir was rapidly abandoned because the scour pipe was jammed by a log which could not be removed. Prior to the incident, water supply from the reservoir was inadequate. The reservoir water level used to drop during dry periods, and the water would turn green and become unfit for use. Altogether the reservoir silted up very quickly by bed-load transport and was disused in less than 20 years. Note that, although the original volume of the reservoir was $27\,280 \text{ m}^3$, the catchment area is only about 3 km^2 (Table 1)!

The Korrumbyn Creek Dam had an insufficient catchment area (3 km²). The stream discharge was very irregular and the reservoir could not fulfil the water needs. Further the catchment is very steep (bed slope $>7.6^\circ$) and the channel bed contains a wide range of sediment materials. A rapid reservoir siltation by bed-load could be predicted with today's experience (in the opinion of the first

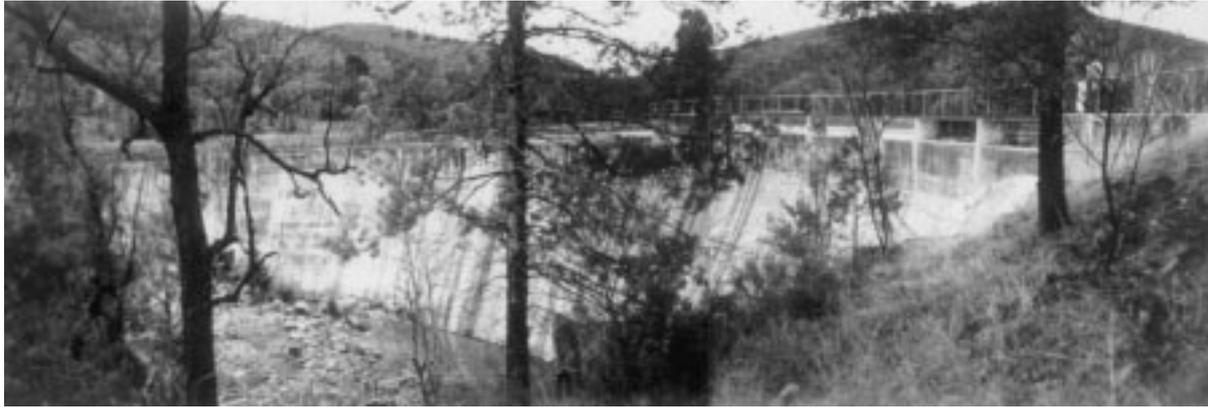
Fig. 6. Photograph of the Quipolly Dam, from the right bank. Photograph taken on 13 June 1997 (by H. Chanson).

15% of the initial reservoir capacity was silted between 1932 and 1941. In 1943 the siltation volume amounted to 34% of the initial capacity. By 1952, more than half of the initial storage had disappeared. The reservoir was abandoned in 1955 at the completion of the Quipolly Dam No. 2, located 3 km downstream. The (old) Quipolly Reservoir is fully silted nowadays. Although the Quipolly Reservoir is 'officially' disused, it has become a sediment trap preventing efficiently the sedimentation of the Quipolly Reservoir No. 2.

The siltation of Quipolly Reservoir is probably related to soil erosion of the catchment, in connection with improper catchment management. Note that the reservoir is the only one of the four which retains some usefulness today: i.e., a sediment trap for Quipolly Dam No. 2.

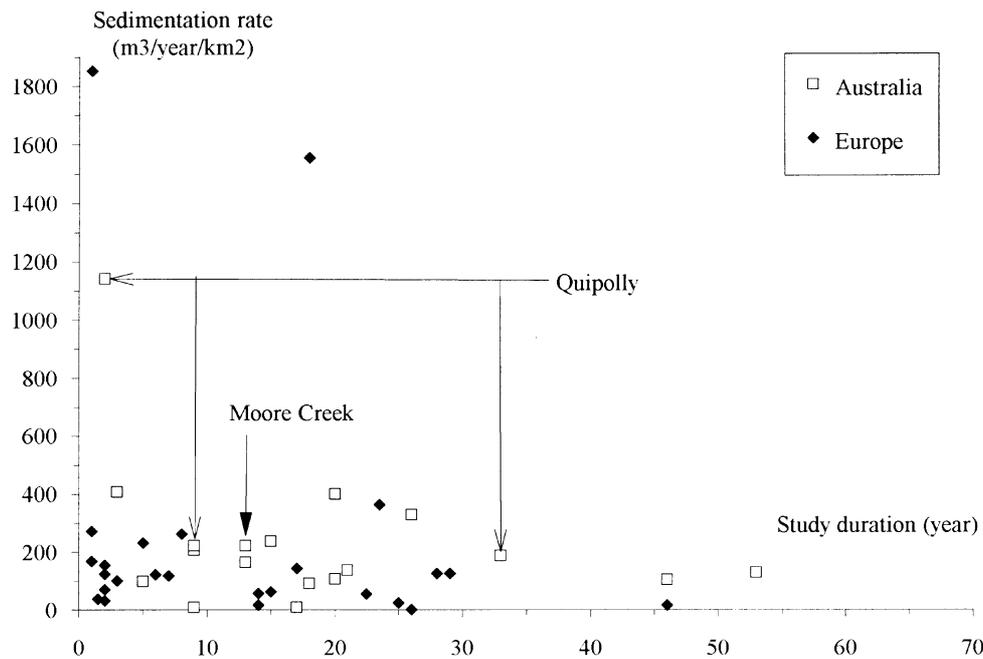
It is interesting to compare the sedimentation rate of the reservoirs with other structures. Figure 7 presents the siltation rate of Moore Creek and Quipolly reservoirs (in m³ per km² of catchment and per year) as a function of the study period (i.e. period between consecutive observations). (Note that 1 m³/km²/year = 0.55 tonnes/km²/year,

Fig. 7. Sedimentation rates in m^3 per km^2 of catchment and per year: extreme sedimentation cases in Australia and in Central Europe [17, 18].

assuming sandy sediment material.) The data are compared with large sedimentation rates observed in Australia (e.g. Corona, Stephens Creek and Umberumberka near Broken Hill NSW) and in Central Europe. In Fig. 7, each siltation rate could be considered as very significant.

The results (Fig. 7) indicate that the siltation rates at Moore Creek and Quipolly were important and similar to other extreme situations. However most reservoirs included in the study plot (Fig. 7) were not fully-silted in less than 25 years!
